# ICC: A Breakthrough In Quality

# ICC IN IMPROVING REJECTION RATE OF THE FRAMES

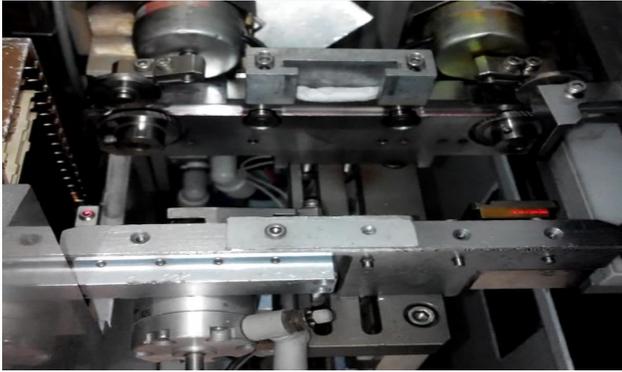
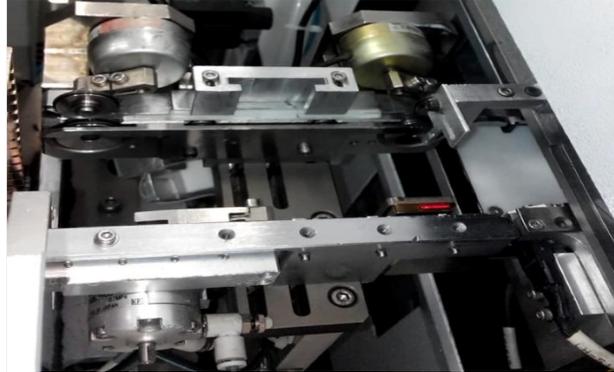
1. Metal roller was changed to rubber roller

Root Cause	Action Taken
Frame stuck at metal roller	<ol style="list-style-type: none"> <li>1. Metal roller was changed to rubber roller <ul style="list-style-type: none"> <li>• The surface of the rubber roller balanced and the frame moved without any vibration as well as absence of foreign materials were recorded</li> </ul> </li> </ol>
Frame stuck in between Feeder motor 1 & 2	<ol style="list-style-type: none"> <li>2. Feeder motor was equipped with speed control <ul style="list-style-type: none"> <li>• Incorporated circuit that regulates speed of the feeder motor</li> </ul> </li> <li>3. Electronic circuit with sensor was used to cut off current supply if jamming occurs</li> </ol>
Dented magazine blocked frame movement	<ol style="list-style-type: none"> <li>4. Developed a magazine inspection jig <ul style="list-style-type: none"> <li>• Magazine inspection jig is used to inspect magazine condition before using it</li> </ul> </li> </ol>

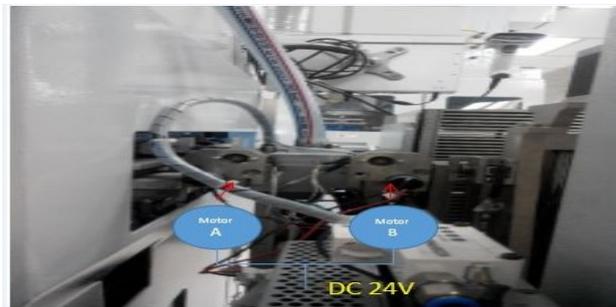
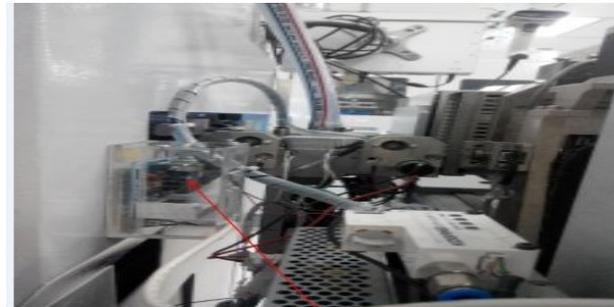
2. Feeder motor with speed control

- Rotation Of DC 24 V Motor without speed control.

- Incorporated circuit that regulate speed of the motor.

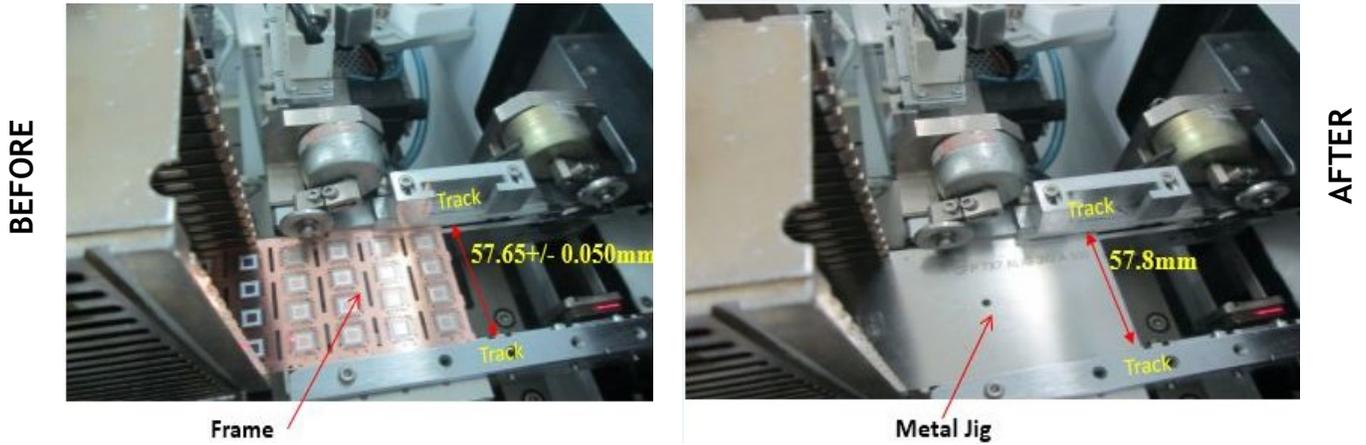
## 5. Developed metal jig

Alignment out of original position at the input loader	<ol style="list-style-type: none"> <li>5. Developed a metal jig <ul style="list-style-type: none"> <li>• Metal is used for a perfect jig setup by maintenance operators for alignment between magazine and track</li> </ul> </li> <li>6. Changed the track width to fix position by activating the sensor to prevent any reset action</li> </ol>
Input elevator shifted from actual position	<ol style="list-style-type: none"> <li>7. Placed a bracket in between the input elevator and the mold track <ul style="list-style-type: none"> <li>• Plastic guard around the machine is placed to prevent the trolley from hitting the input elevator</li> </ul> </li> </ol>
