Initiatives towards Obtaining a Better Customer Satisfaction

By Nur Hanim Abd. Ghani

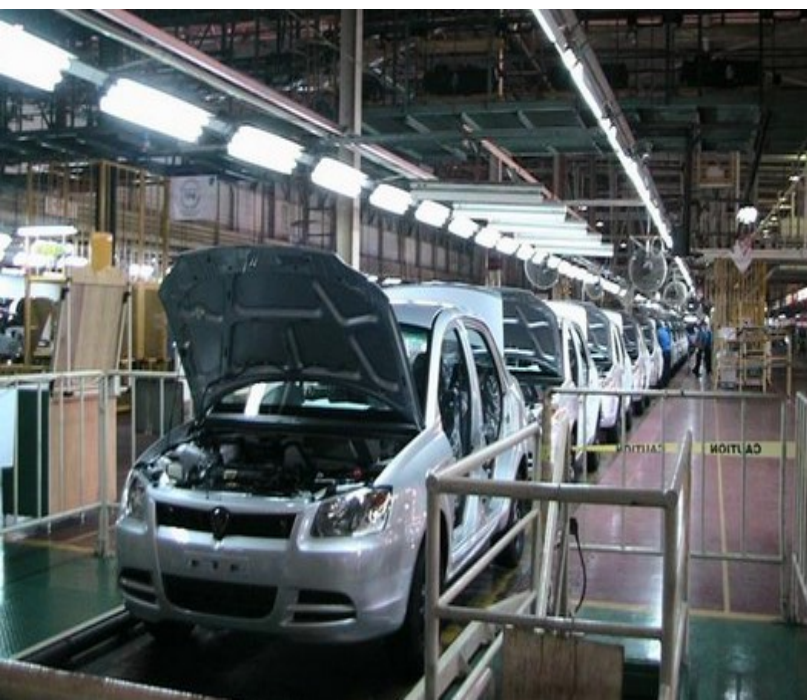
Defects occurred in the cylinder block production line

Following the target of improving work processes, a brainstorming session was held among the team members. Dream identified 18 problems that could be resolved for improvement purposes. The critical and capability matrix analysis had further made the team to conclude that the cleanliness of cylinder block after washing process of OP#16 machine was the major problem for their ICC project. It was recorded in August 2012, a total of 185 cylinder blocks were not clean after the washing process.

This was identified as the highest amount produced by the cylinder block production line. The current washing system was unable to remove excess chips and sludge. Extra rework activities were needed to deliver high quality cylinder blocks to the next stage of engine assembly. Furthermore, the defect cylinder blocks had delayed the engine assembly process which required an extra time of 85 minutes. It was estimated that the total loss for this problem was RM130,566 per year which involved time, over processing and transportation wastages.

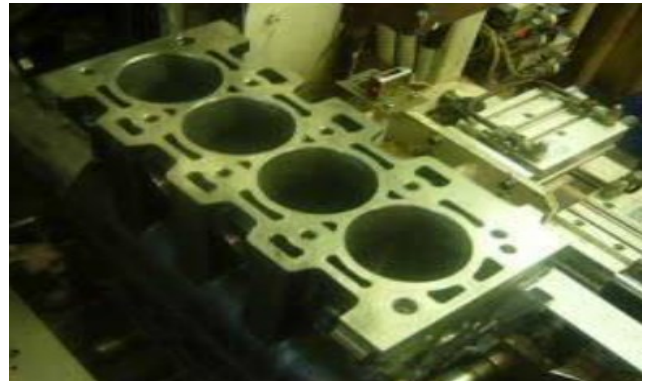
The problem of cylinder block cleanliness was identified as the problem that required rework activities.

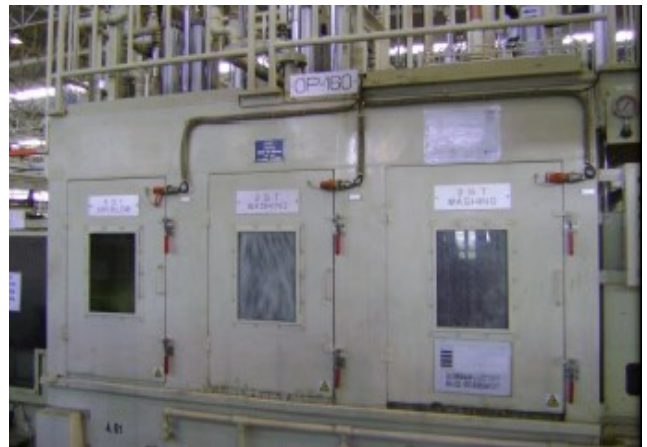
OP#16 machine is for washing process of cylinder block.
